We Want Foam, Too

U.S. compost facility salvaged with SPF

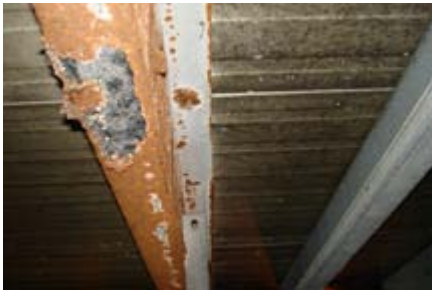
Spray foam installers Barry Burns, Rick Conley, Jeff Conley, Aaron Parsons, and six more crewmen were assigned to the job. With four Graco Gusmer Marksman proportioners and Probler spray guns, they applied foam and coating to the facility's interior. This included 300,000 square feet of walls, ceiling, and all structural steel beams and bracing.

"We did every strut, Z beam, and every support bar that ran from one section of the roof to another," says Lang. "Some steel purlins and Z beams were damaged too badly and were replaced, but every piece of exposed metal in the building was covered with the foam and coating."

FoamCoat sprayed the interior with 1 inch of Preferred Solutions' Staycell spray foam and 1/16th inch of Stayflex non-permeable, polymer thermal barrier. The Staycell foam provided the thermal insulation and eliminated the need to abrasive blast the metal surfaces. The Stayflex thermal barrier blocked the chemical vapors and moisture from reaching the foam and metal.

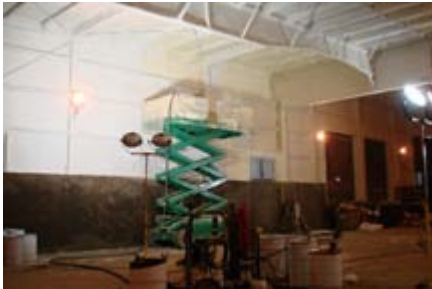
"Everything was wrapped in foam," says Lang. "We wanted to encapsulate the metal so it wouldn't rust."

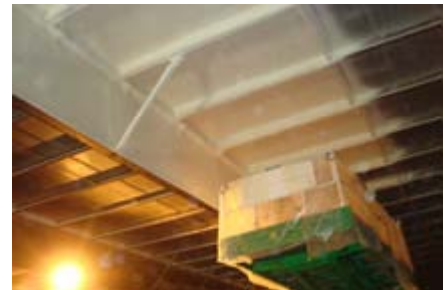
"The roof strut is a 2-inch rod that goes from one section of the roof to another one," Lang explains of the building's interior. "We had to cover every cross beam, Z beam, and support bar. Some of them we sprayed; some we hand-brushed. We could spray a Z beam because we could reach those with a spray gun. But the bars that go between the Z beams, like 2-inch diameter rods that provide extra support, were very close to the roof. Those had to be hand-detailed with brushes. We couldn't just spray it and walk away. There were guys at all times who just did the detail work."
